Silver plating tungsten (W) and tungsten-rhenium (WRe) probes provides advantages over traditional nickel plating by reducing the DC-resistance and increasing the current carrying capacity.

## **CASE STUDY – Burnt Probe Tips**

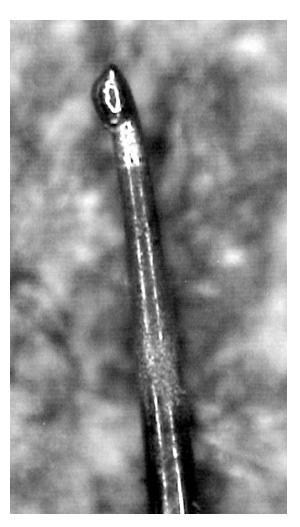
Figure 1 - "Fried" probe tip.

A customer of *Probe* & *Test, Inc.*, was experiencing "fried" probe tips (Figure 1) at certain locations within a probe card.

Apparently, the probes were being damaged by a high forcing current. During device testing, a 10amp DC-current was being distributed over all the power and ground probes

of the probe card – approximately 2½-3-amps of current were being forced through each signal probe. As a result, the probe tips were severely damaged and the probe card required frequent repairs resulting in excessive down time. When the signal and ground probes were replaced with silver plated probes, the burnt tip problem was completely eliminated.
